No.: GT-18-106 Date: 5/23/2018 Sheet 1 of 6 Rev. B

This report summarizes performance testing of Glenair SuperNine (MIL-DTL-38999 type) connectors to determine conformance to the requirements of Bell Helicopter Report No. 299-100-829 (Rev. Basic) for the following tests: Random Vibration, Low Frequency Spectrum Vibration (Sine over Random), and Mating Durability. The information in this report was obtained from tests conducted by Vertical Laboratories. These documents are on file at Glenair, Glendale California, and are available upon request.

Test Report # 18109D1DS0417V2

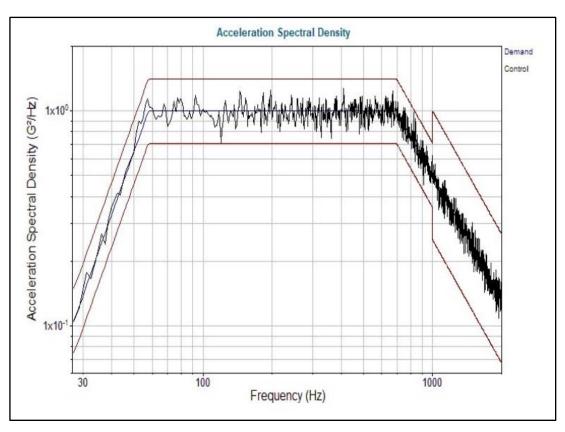
Figure 1:

Random Vibration Test Performed April 4, 2018 & April 9, 2018

test specification. Testing was performed for 8 hours in the parallel axis and 8 hours in the perpendicular axis, for a total duration of 16 hours. **Figure 1** in Appendix shows a snapshot of the spectral density graph. Testing was performed using the test setup defined in figure 3-2 and 3-3 of the test specification (see **Photo 1** & **Photo 2** in the appendix.) A discontinuity monitor capable of detecting a 1 microsecond interruption was used to monitor the test samples throughout the duration of testing.

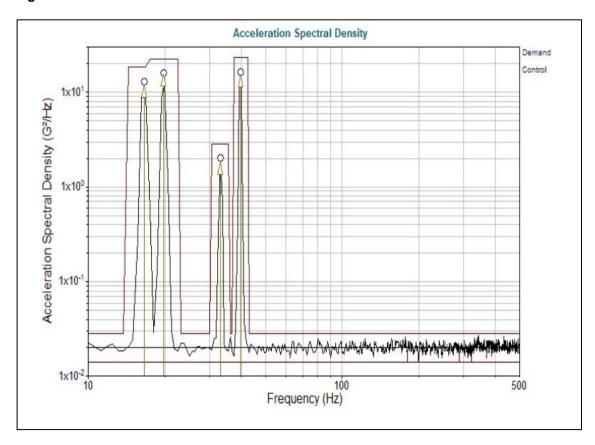
Figure 2:

Low Frequency Spectrum Test Performed April 4, 2018 & April 10, 2018

Low frequency spectrum testing was performed on the test samples in accordance with paragraph 4.11.7 of the test specification. Testing was performed for 2 hours in the parallel axis and 2 hours in the perpendicular axis for a total duration of 4 hours. **Figure 2** in Appendix shows a snapshot of the spectral density graph. In order to account for the time it takes for the profile to equalize at given levels, an additional 2 minutes was added to the duration of each test. Testing was performed using the test setup defined in figure 3-2 and 3-3 of the test specification (see **Photo 1** & **Photo 2** in the appendix.) A discontinuity monitor capable of detecting a 1 microsecond interruption was used to monitor the test samples throughout the duration of testing.
